Manhole Inspection Summary

Manhole # S31M__009MH

Location Address: **333 W CAMDEN ST**

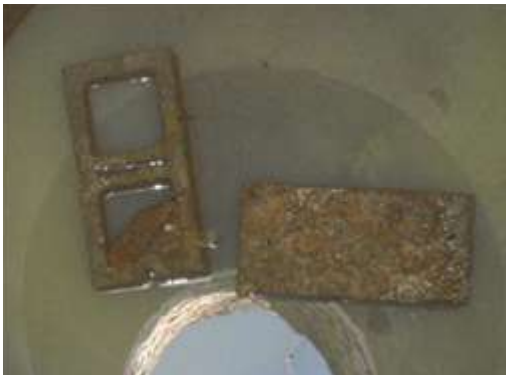
Defect 3

Condition: ☐ Sound ☐ Cracked ☐ Root Intrusion ☐ Deteriorated ☐ Leaks ☒ **Debris**

CINDERBLOCKS IN CHANNEL

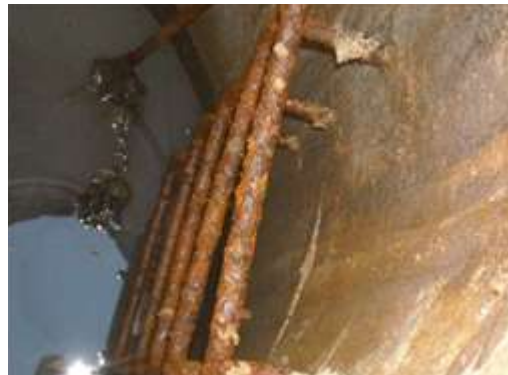
Defect 2

Steps Count: **6** Missing: **0** ☒ **Corroded**

CORRODED STEPS

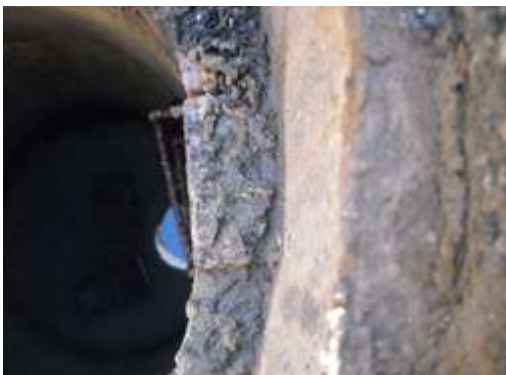
Defect 1

Frame Offset: **3** (in.) Condition: ☒ Sound ☐ Cracked ☐ Leaks

FRAME OFFSET 3"

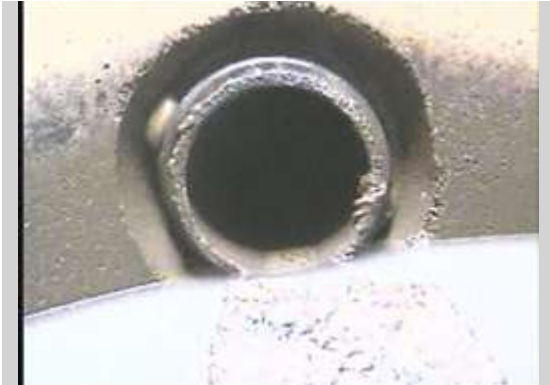
12 O'Clock Outflow

12 in. Circular Gravity Sewer
Pipe Out @ 12 O'Clock

Infiltration: **None** Pipe Seal Cond: **Sound**

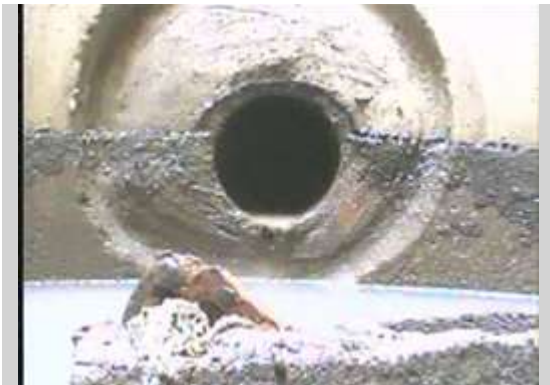
6 O'Clock Inflow

8 in. Circular Gravity Sewer
Pipe In @ 6 O'Clock

Infiltration: **None** Pipe Seal Cond: **Sound**
